# **Field Report for Airborne Data Collected In Support of US EPA Region 6 South 4 Group Fire 05 December 2019**

The US EPA Region 6 requested that the ASPECT system be deployed to provide monitoring support beginning on 27 November 2019. This report summarizes findings observed during the two missions flown on 04 December 2019.

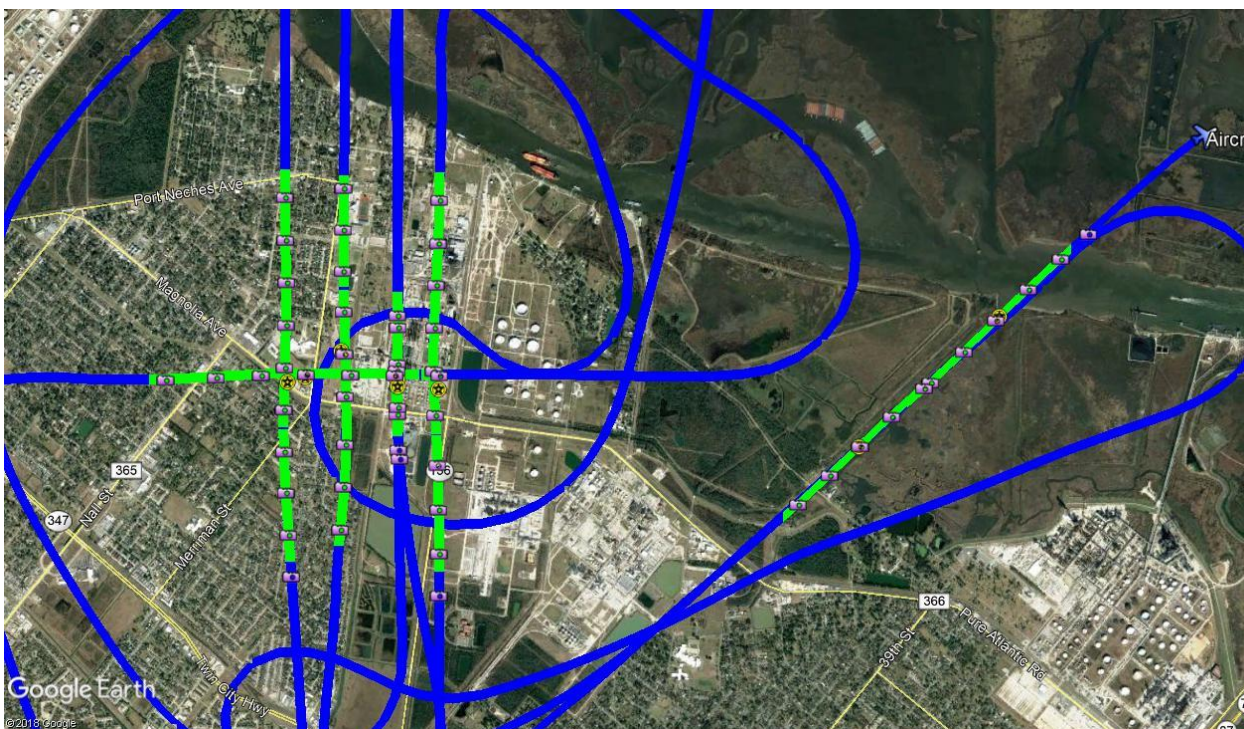
Figure 2: Data collection passes, Flight 16, South 4 Group Fire, Port Neches, TX. The blue lines represent the ASPECT flight path, green lines represent when the FTIR was actively collecting data, the yellow icons with star is the centroid of the line scanner image, and the camera icons represent when a photo was taken.

The order to launch flight 16 was given at 0750 central on 5 December 2019 with the aircraft reporting wheels up at 0920. The initial data collection run over the site was at 0944 (central) The aircraft made a total of 9 data collection passes; flight information is summarized in Appendix Flight #16 and Figure 2.

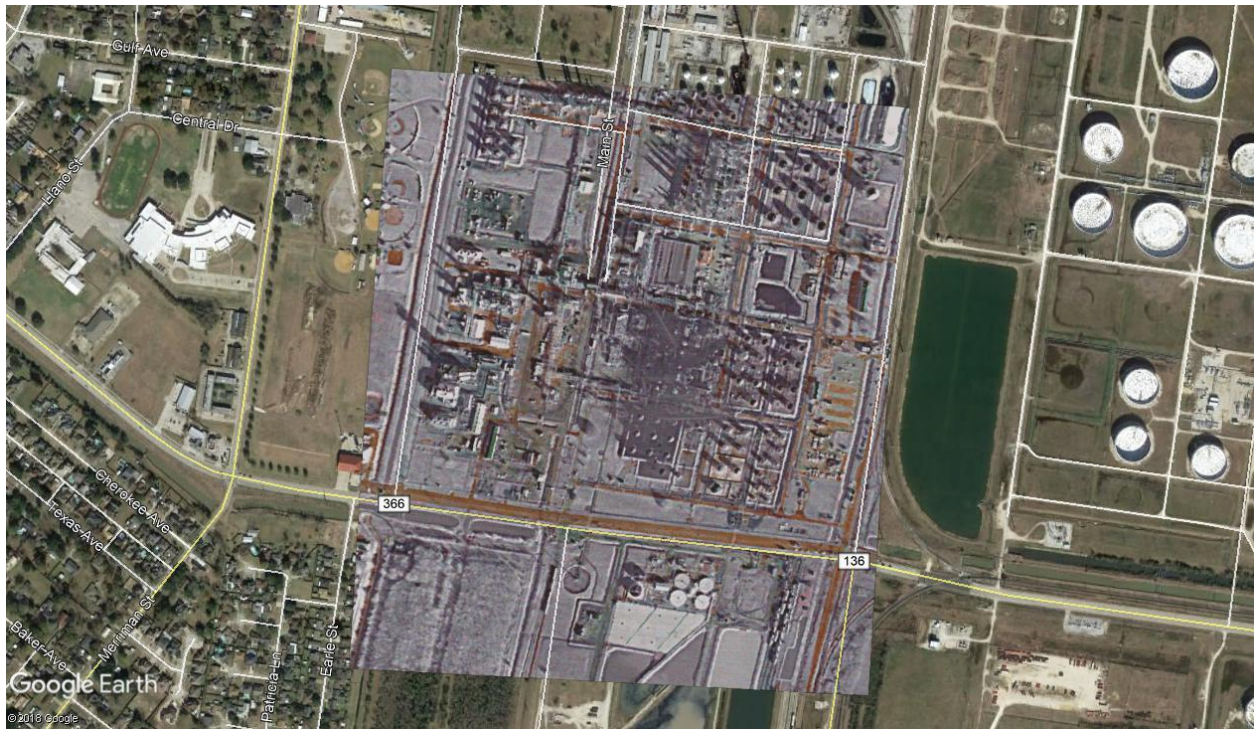
A total of 2 test and 8 data collection passes were made in the proximity of the fire and an infrared line scanner image was generated for each pass. Figure 3 shows a typical 3-band infrared image obtained from data collected for Run 5. Analysis of the image shows a flat thermal environment for the process unit other than isolated spots heated by solar radiation. As reported by the crew, IR imagery showed no evidence of a plume being emitted from the site. The thermal environment of the unit continues to be low. Figure 4 shows a thermal close-up of the process unit with the only noteworthy content being the low thermal levels generated by 5 water cannons being to flood the process unit and nearby tanks. To assess possible oil sheen presence on the Naches River, ASPECT collected IR data along the drainage waterway leading into the river (figure 5). No oil sheen signatures were detected.

Figure 3: – 3 band IR image, Flight 16, Run 5, South 4 Group Fire

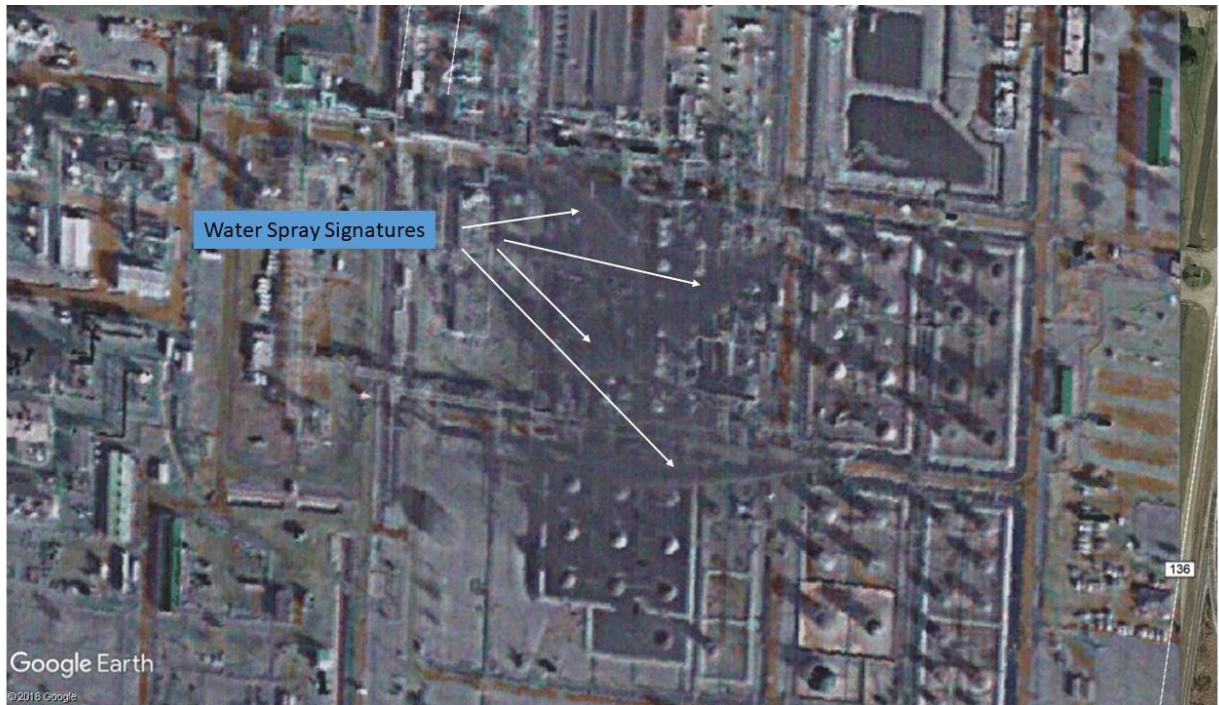
Figure 4: -- 3 band IR Image, Flight 16, Run 7, South 4 Group Thermal Image

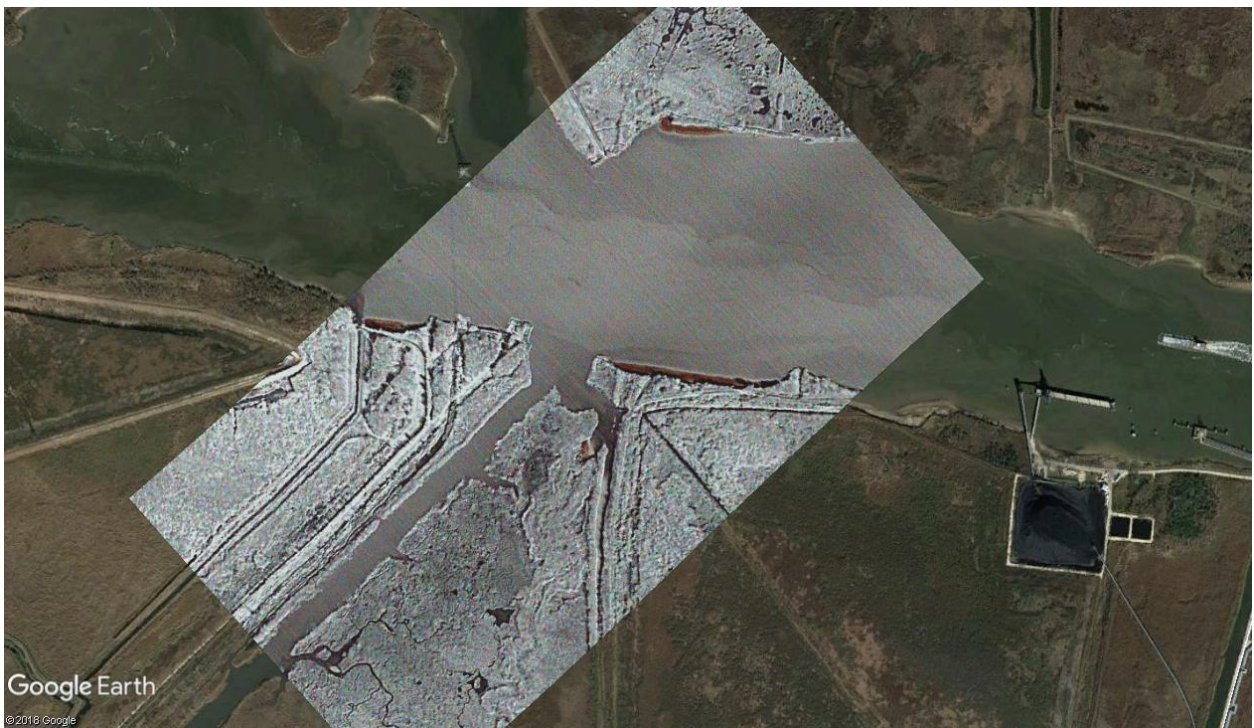
Figure 5: -- 3 band IR Image, Flight 16, Run 10, South 4 Group Waterway Image

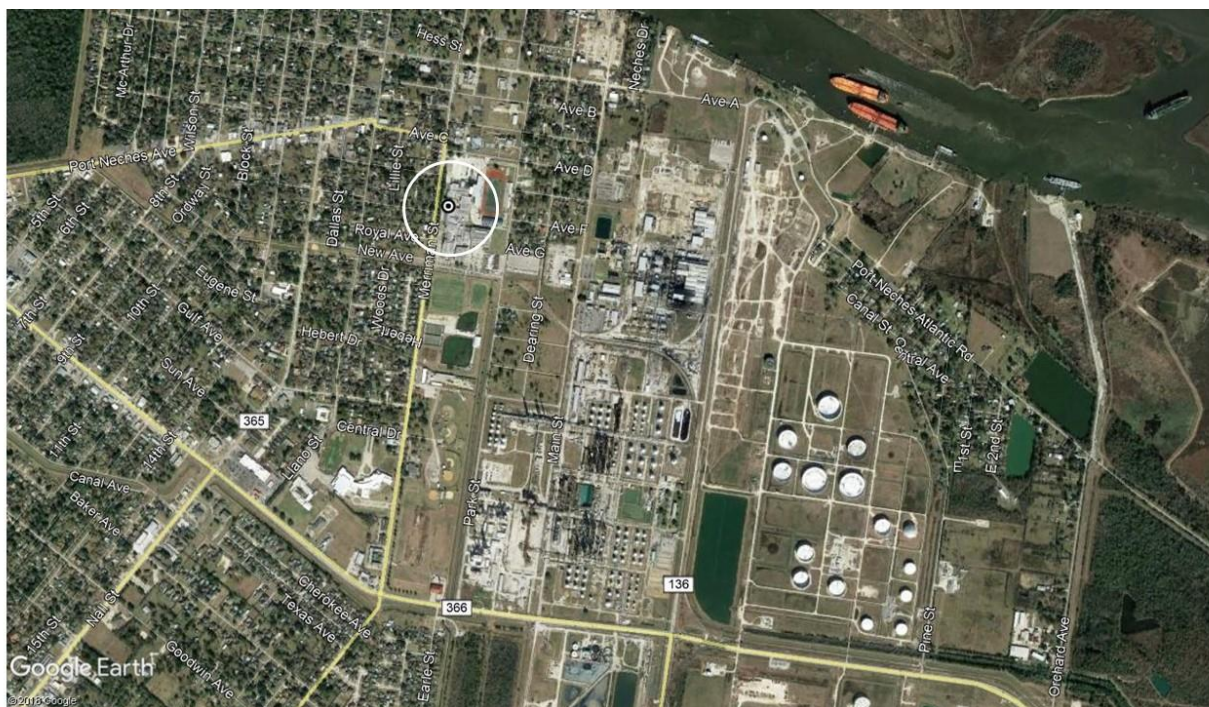
Low level detections of ethylene were made near the school northwest of the facility. Figure 6 shows the locations of the detections. Detected concentrations were just above the detection limit of the system with a maximum reading of 0.522 ppm. Figure 7 shows a confirmation spectrum with the characteristic ethylene peak at 950 wave numbers. A summary of data of the data collection is given in table 3.

Figure 6: -- Ethylene Detection, Flight 16, South 4 Group Waterway Image

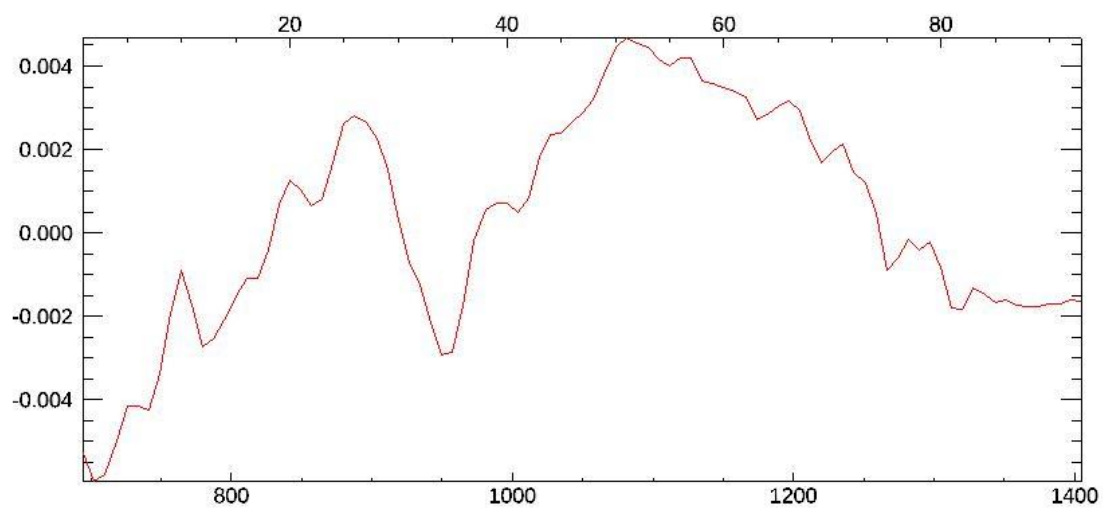
Figure 7: -- Ethylene Detection Spectrum, Flight 16, South 4 Group Waterway Image

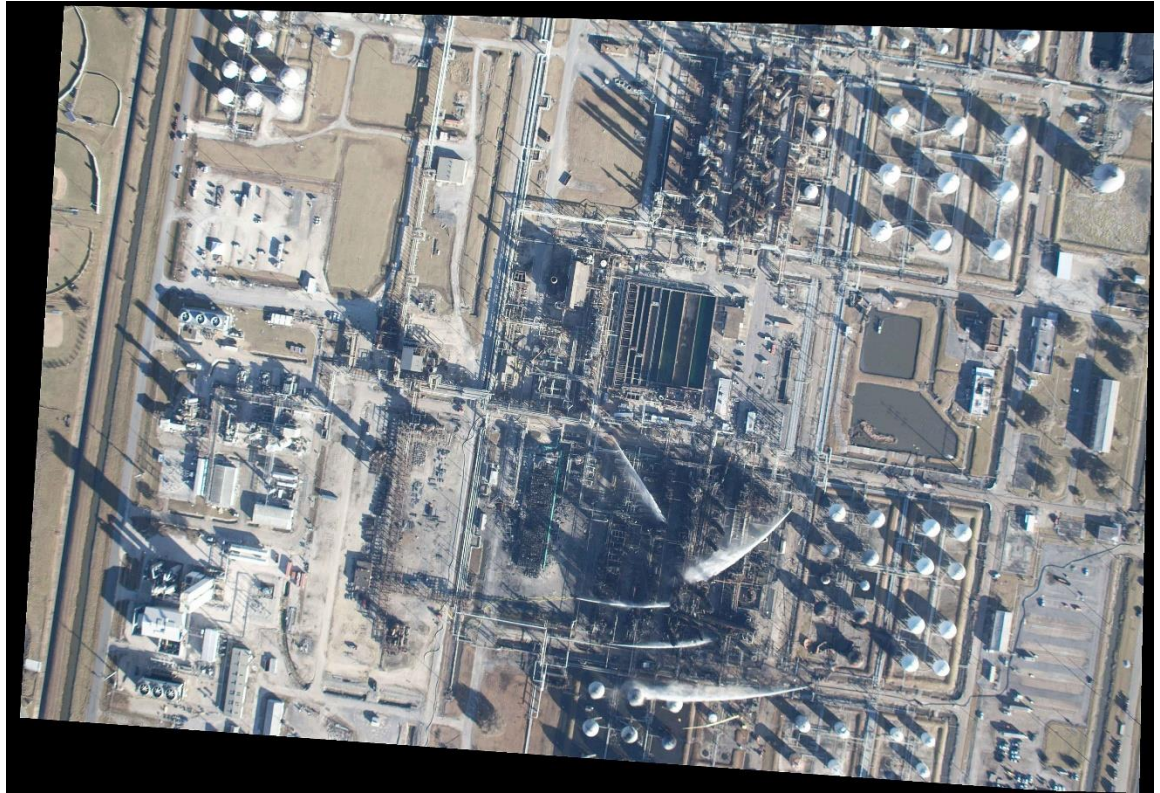
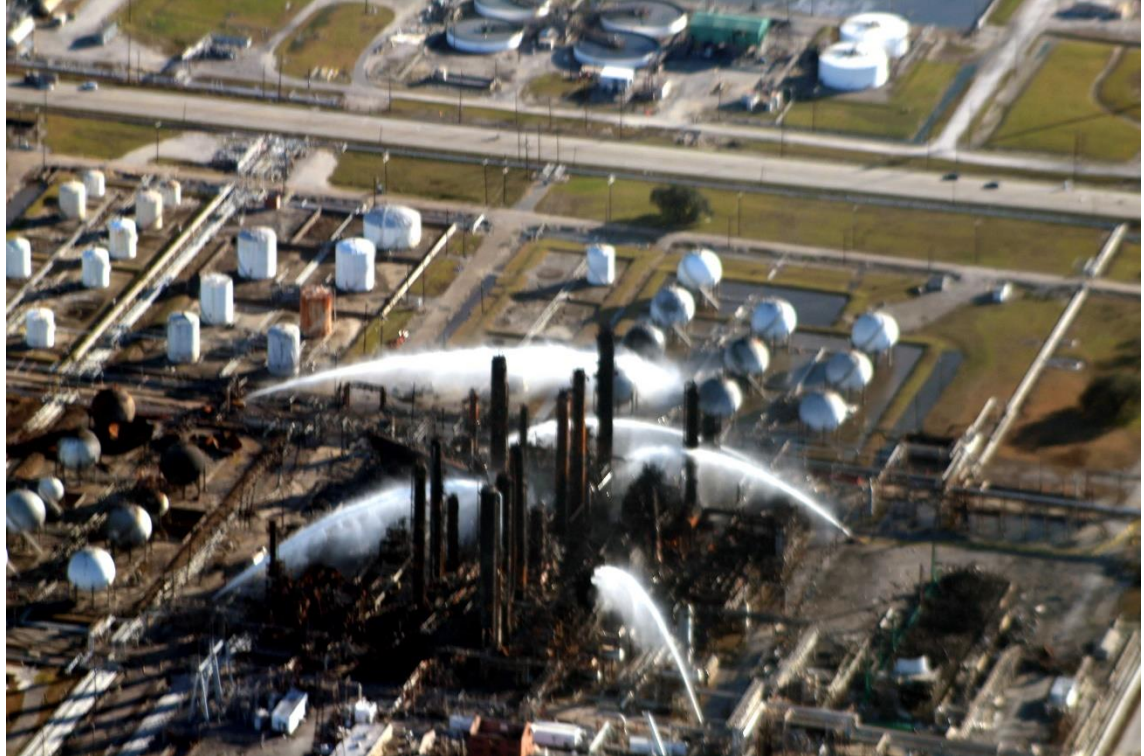
A full set of high resolution aerial digital photography were collected as part of the flight. Figure 8 and 9 show representative views of the process unit with a 5 cannon flood. No emissions are visible in these images.

Figure 8: Aerial Image, Flight 16 South 4 Group Fire.

Figure 9: Oblique Image of the South 4 Group Fire

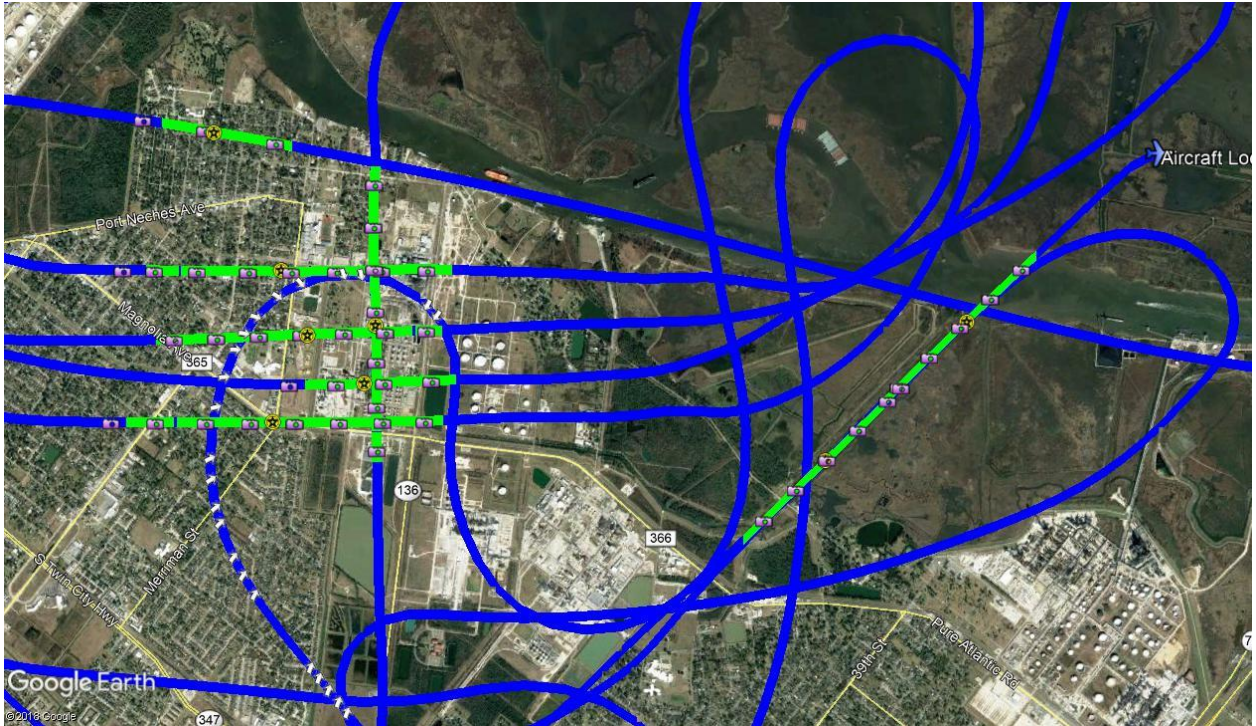
Figure 10: Data collection passes, Flight 17, South 4 Group Fire, Port Neches, TX. The blue lines represent the ASPECT flight path, green lines represent when the FTIR was actively collecting data, the yellow icons with star is the centroid of the line scanner image, and the camera icons represent when a photo was taken.

The order to launch flight 17 was given at 1445 central on 5 December 2019 with the aircraft reporting wheels up at 1457. The initial data collection run over the site was at 1526 (central) The aircraft made a total of 7 data collection passes; flight information is summarized in Appendix Flight #17 and Figure 10.

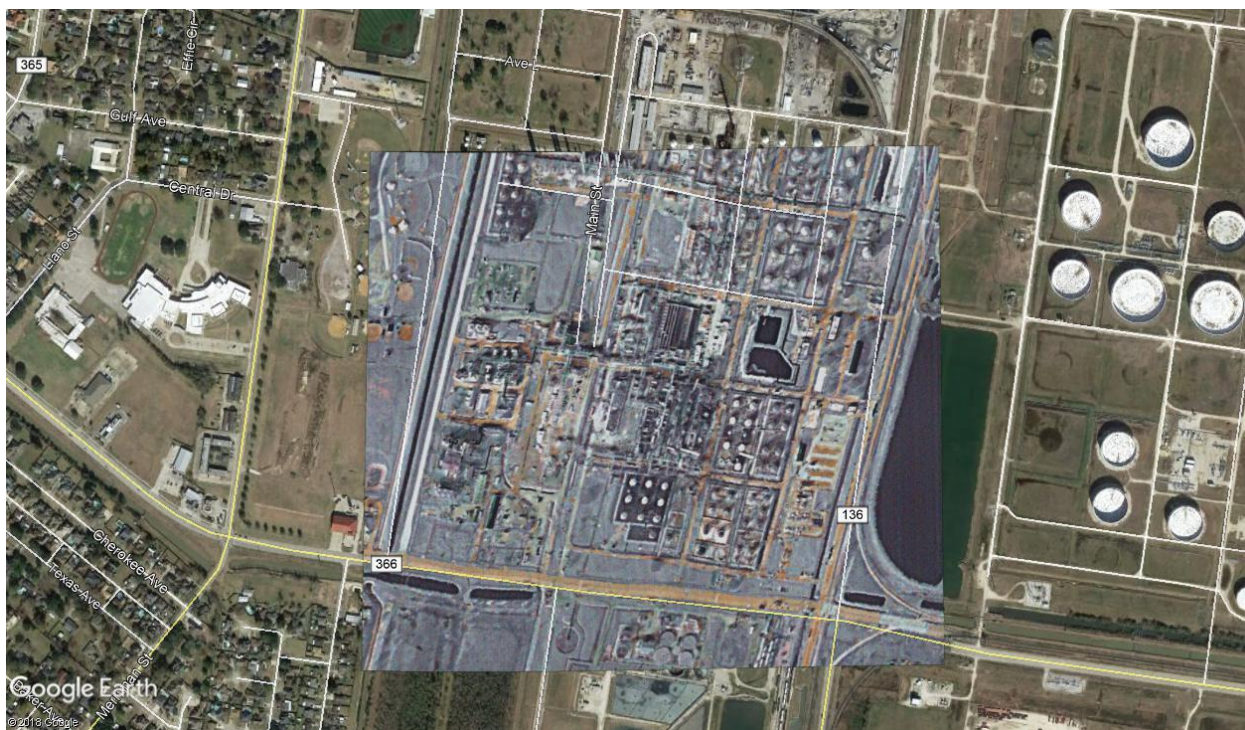
A total of 1 test and 7 data collection passes were made in the proximity of the facility and an infrared line scanner image was generated for each pass. Figure 11 shows a typical 3-band infrared image obtained from data collected for Run 2. Analysis of the image shows a flat thermal environment for the process unit other than solar heating of tanks and metal surfaces. Smoke or other emissions are absent in the imagery. A closeup thermal image (figure 12) shows only solar heating. At the time of the IR collection, the signatures of water cannon are not present. A collection pass over the confluence of the drainage waterway and Naches River shows tidal effects pulling water out of the channel but no oil sheen signatures were detected (figure 13).

Figure 11: – 3 band IR image, Flight 17, Run 1, South 4 Group Fire

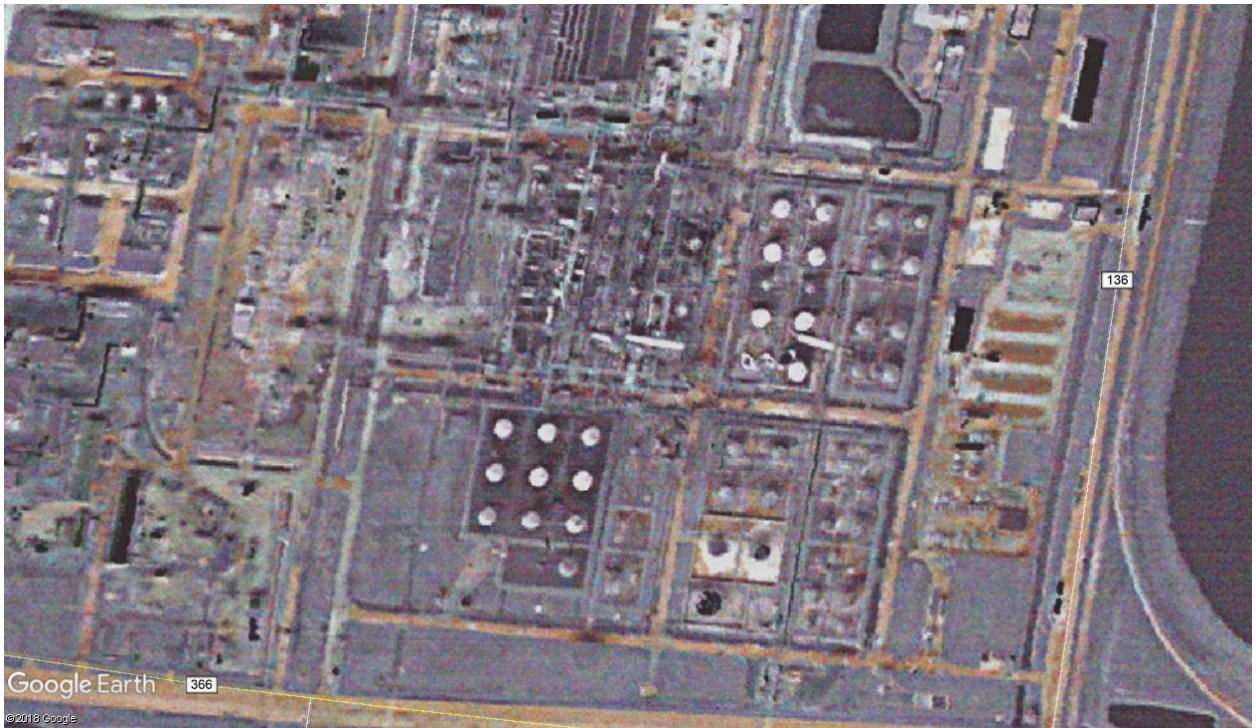
Figure 12: -- 3 band IR Image, Flight 17, Run 5, South 4 Group Thermal Image

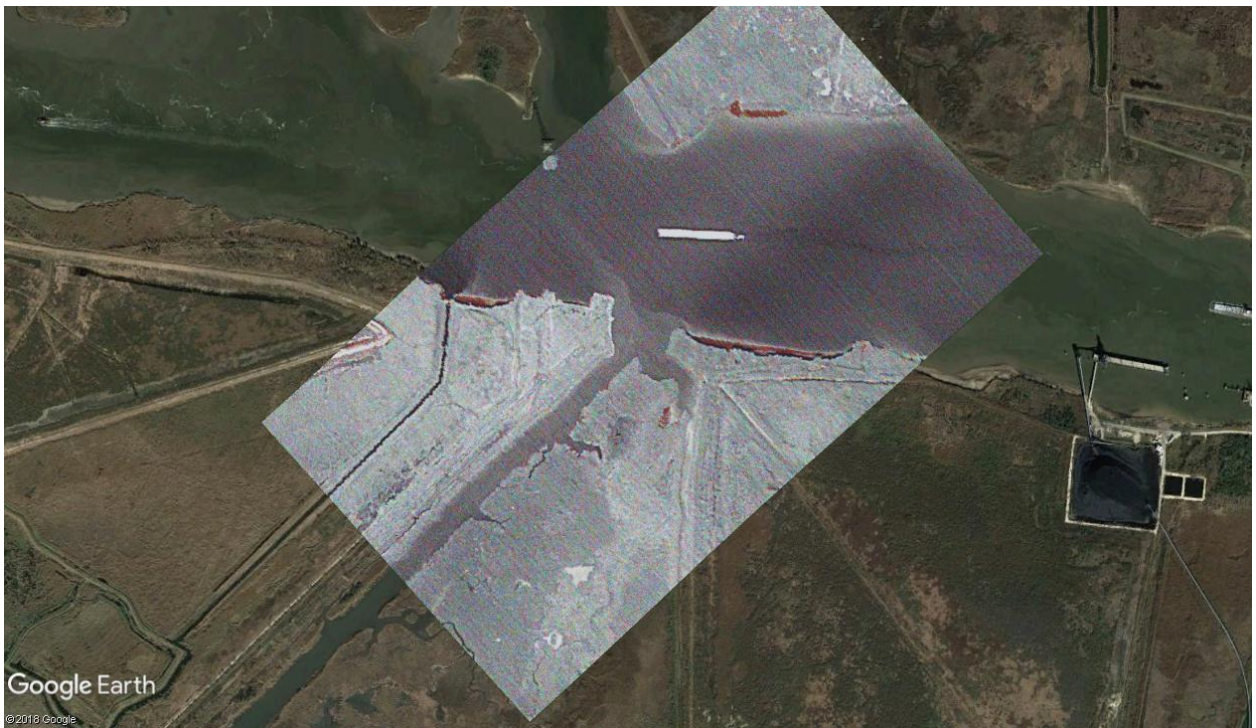
Figure 13: -- 3 band IR Image, Flight 17, Run 8, South 4 Group Waterway Image

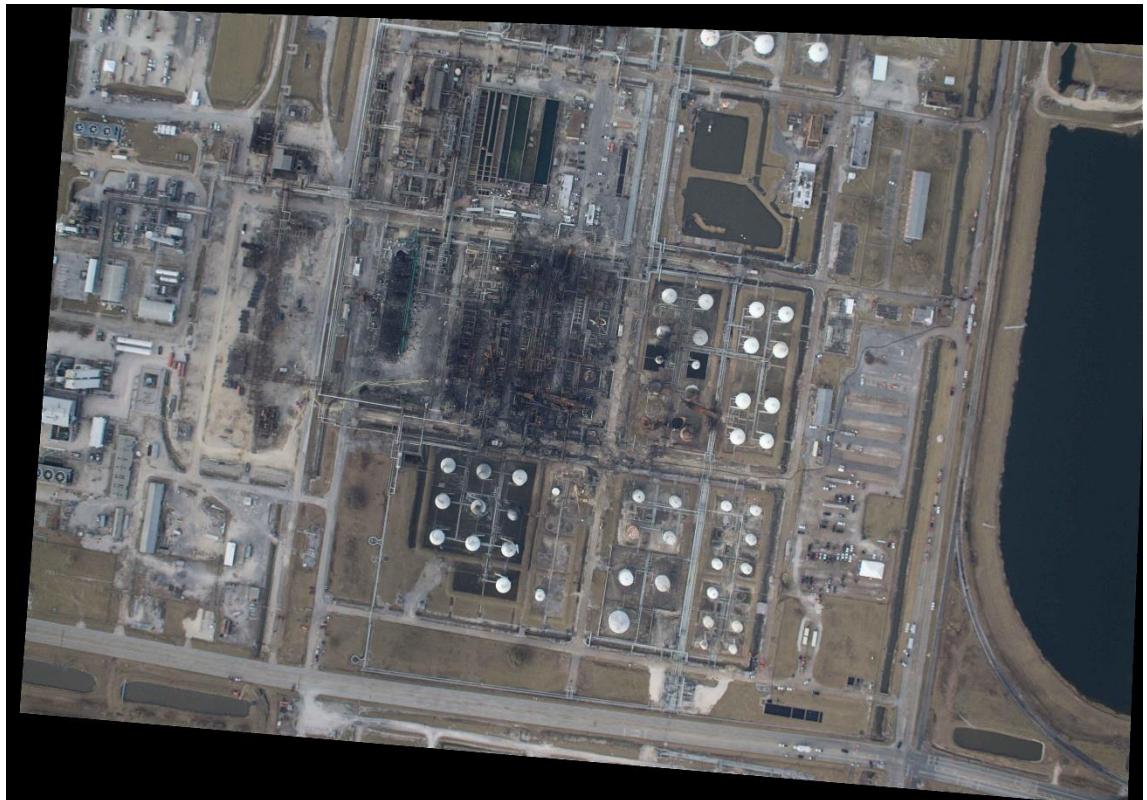
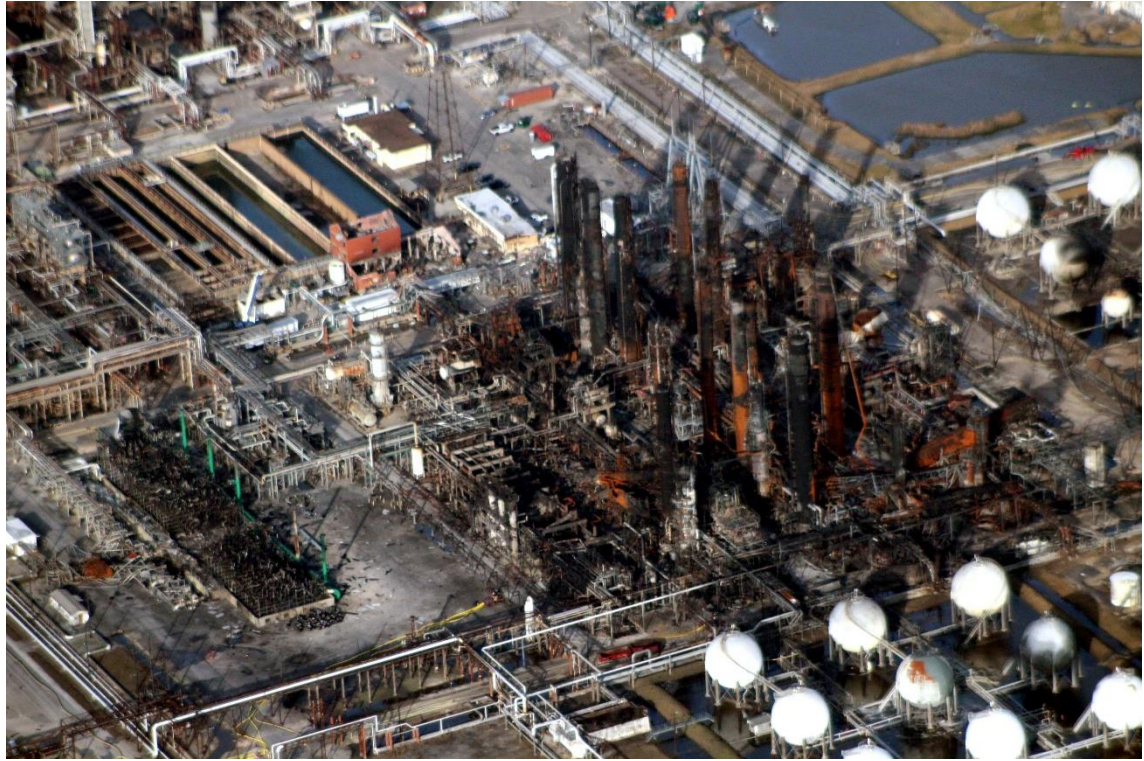
A full set of high resolution aerial digital photography were collected as part of the flight. Figure 14 and 15 show representative views of the process unit and tank farm. No emissions are visible in these images.

Figure 14: Aerial Image, Flight 16 South 4 Group Fire.

Figure 15: Oblique Image of the South 4 Group Fire
